Richard B. Russell Dam and Lake

Final Foundation Report Volume 2 of 2

US Army Corps
of Engineers
Savannah District

RICHARD B. RUSSELL PROJECT
SAVANNAH RIVER, GEORGIA AND SOUTH CAROLINA
FINAL FOUNDATION REPORT
CONCRETE DAM, EMBANKMENTS, AND POWERHOUSE

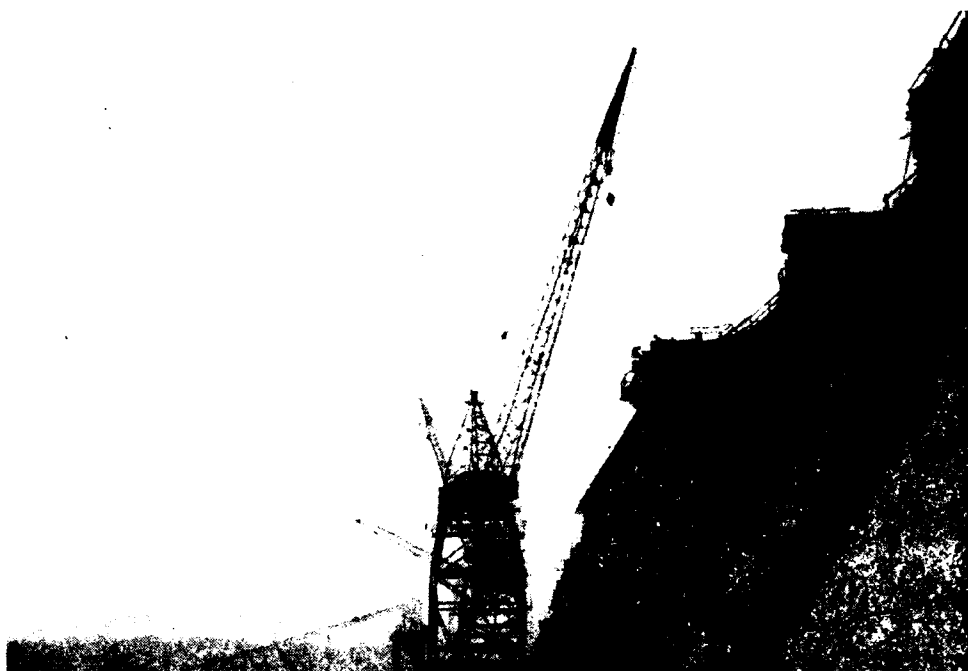
Photo 32 - Spillway training wall - note North Carolina non-overflow Monoliths 26 and 27, right side of photo.

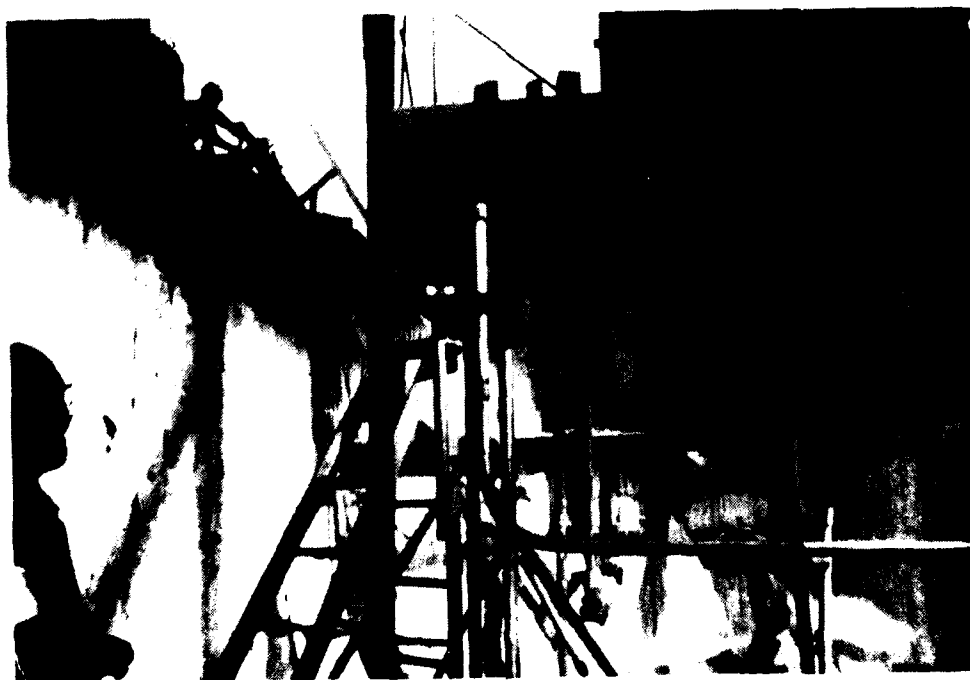
Photo 40 - Uplift cell installation, Block 10 - note future
read out-box, center (November 1979)

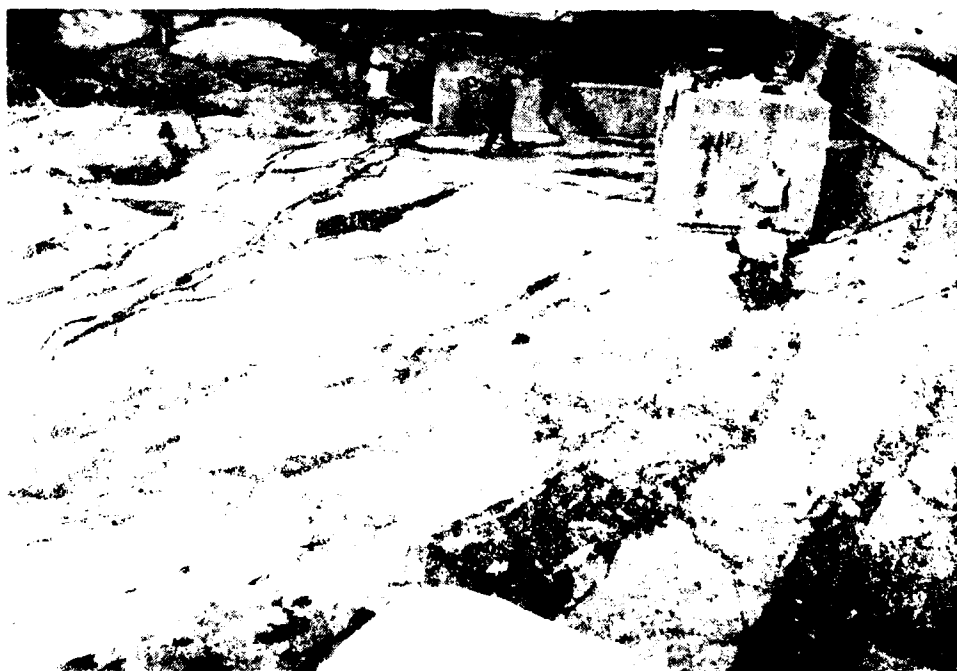
Photo 78 - Monolith 19 foundation (August 1979)

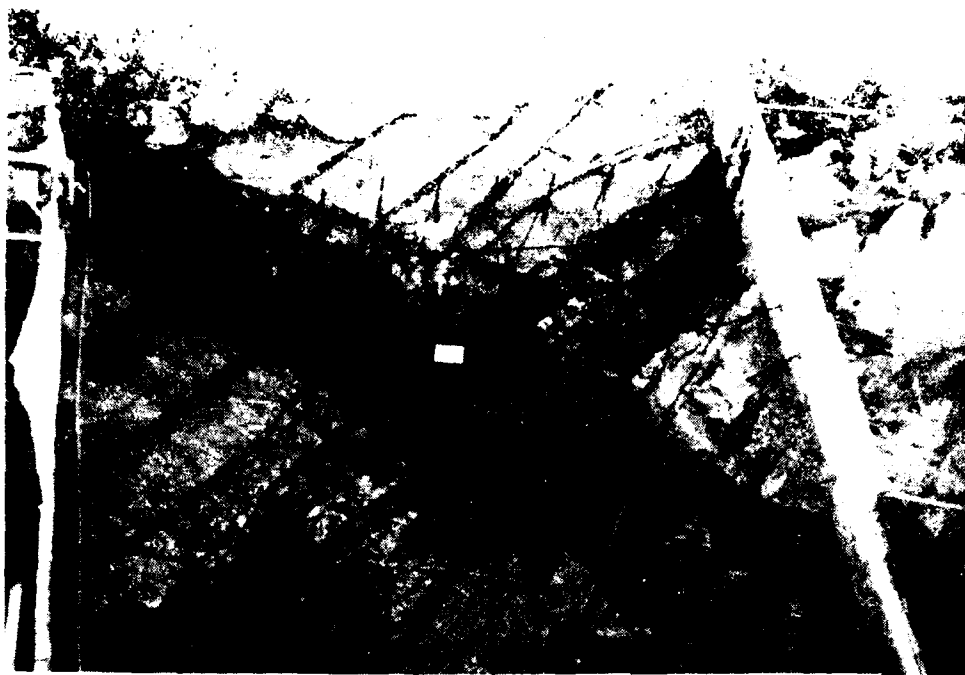
Photo 83 - Monolith 22 foundation (December 1979)

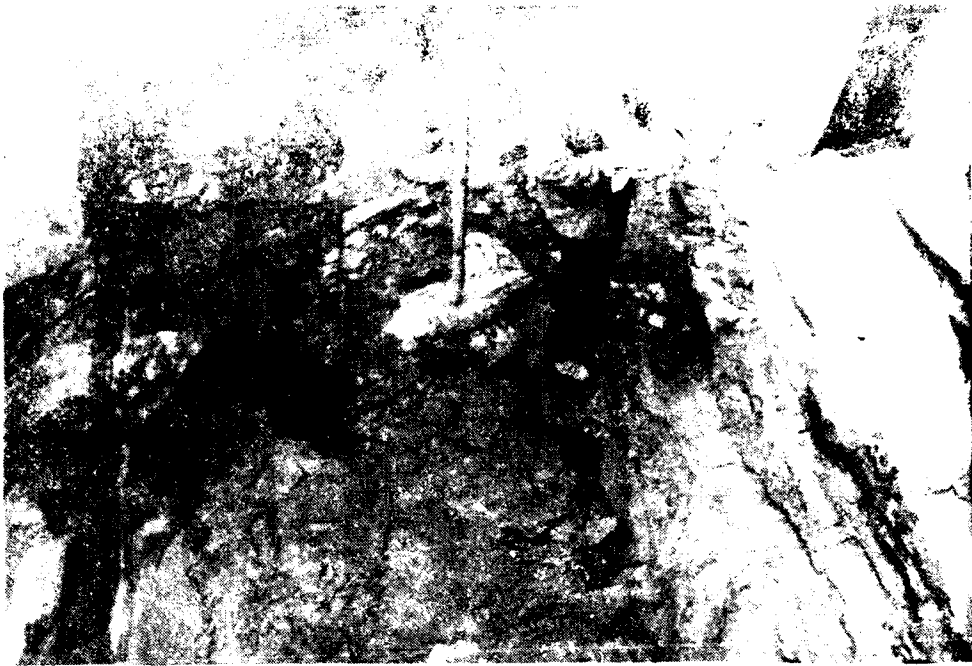
Photo 85 - Monolith 23 foundation (February 1980)

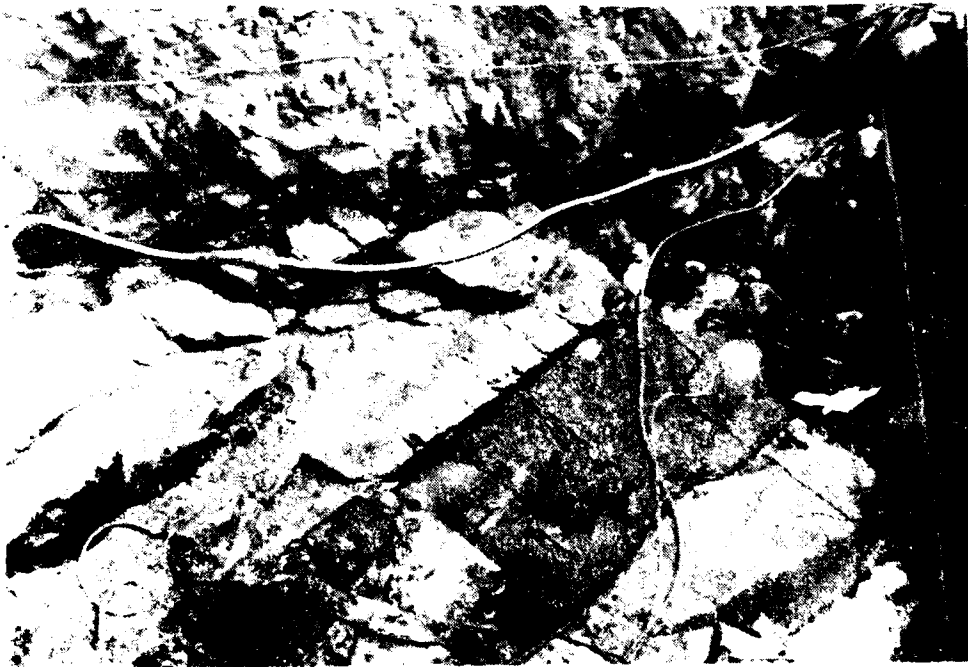
Photo 86 - Monolith 25 foundation (April 1980)

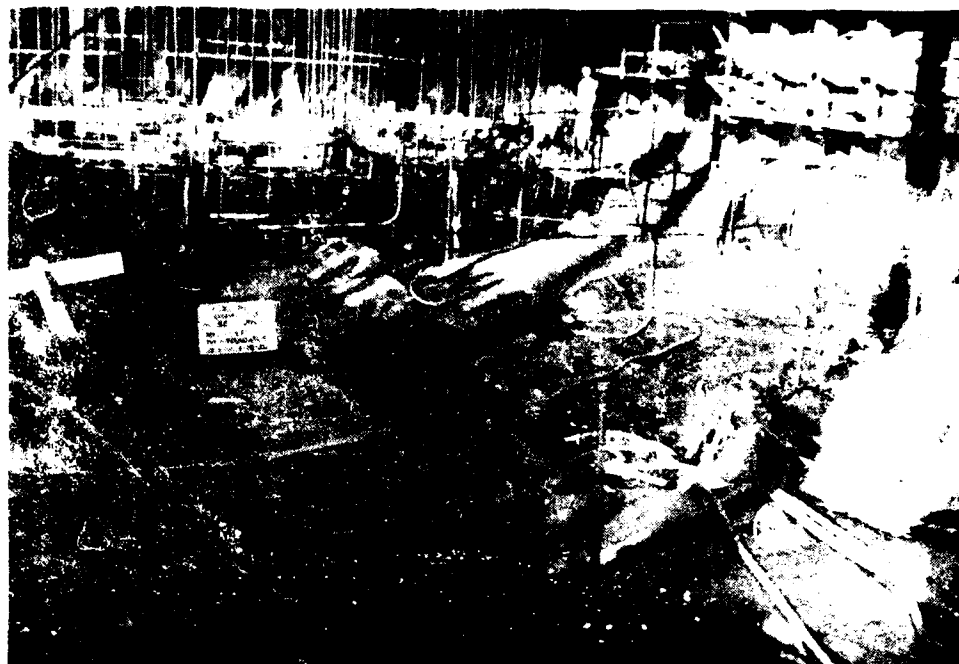
Photo 89 - Monolith 27 foundation (January 1980)

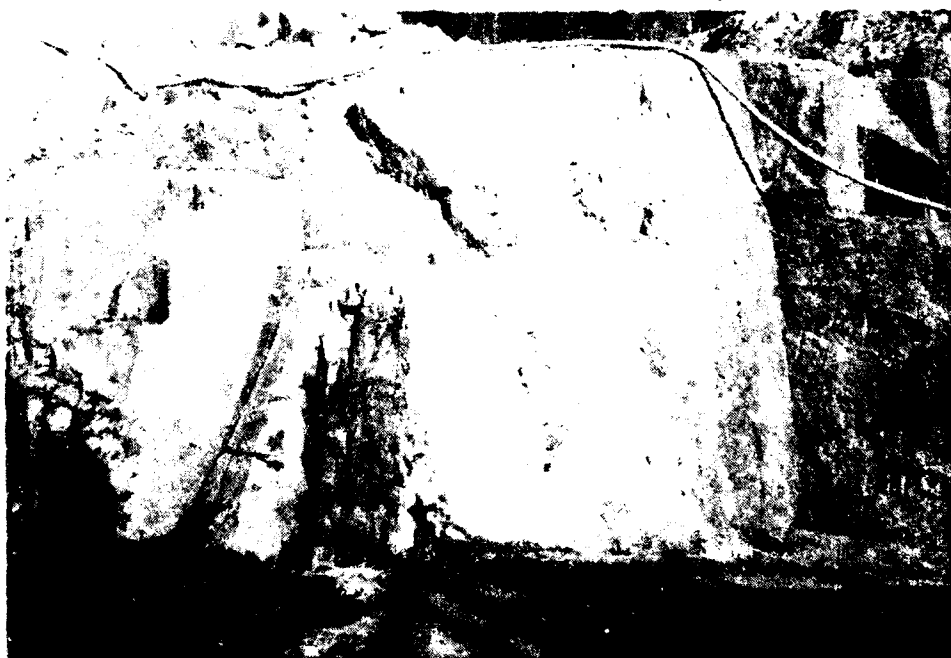
Photo 92 - Monoliths 28/29 Step-up (March 1970)

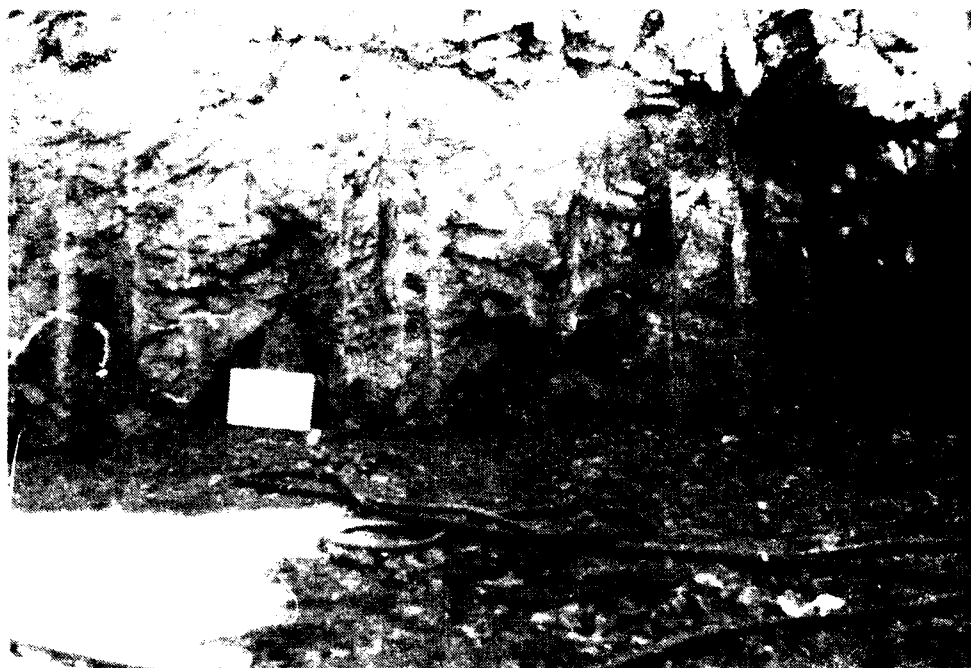
Photo 93 - Monoliths 28/29 Step-up face (February 1980)

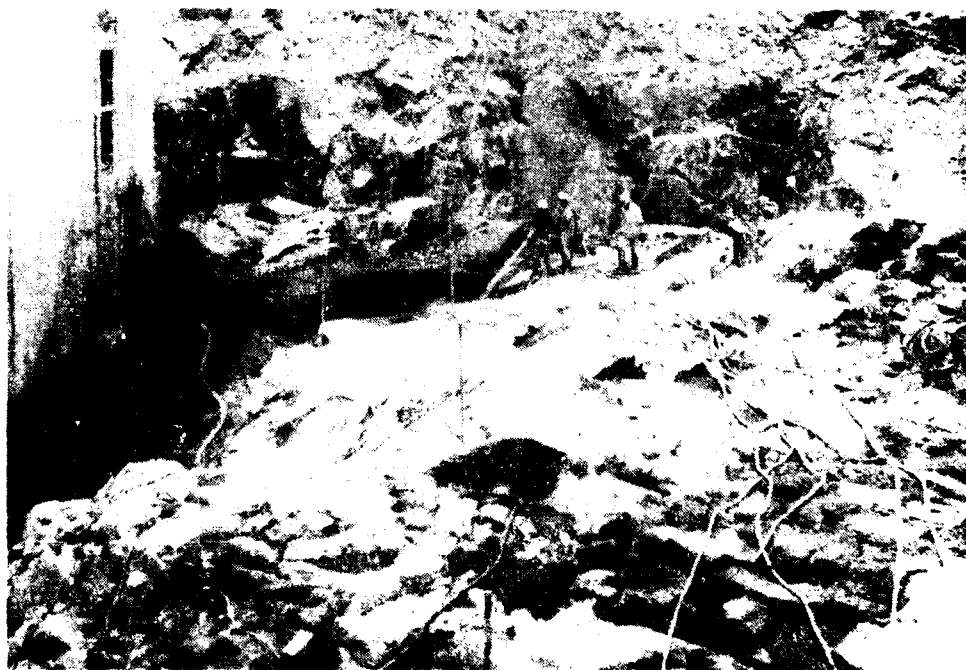
Photo 94 - Monolith 29 foundation

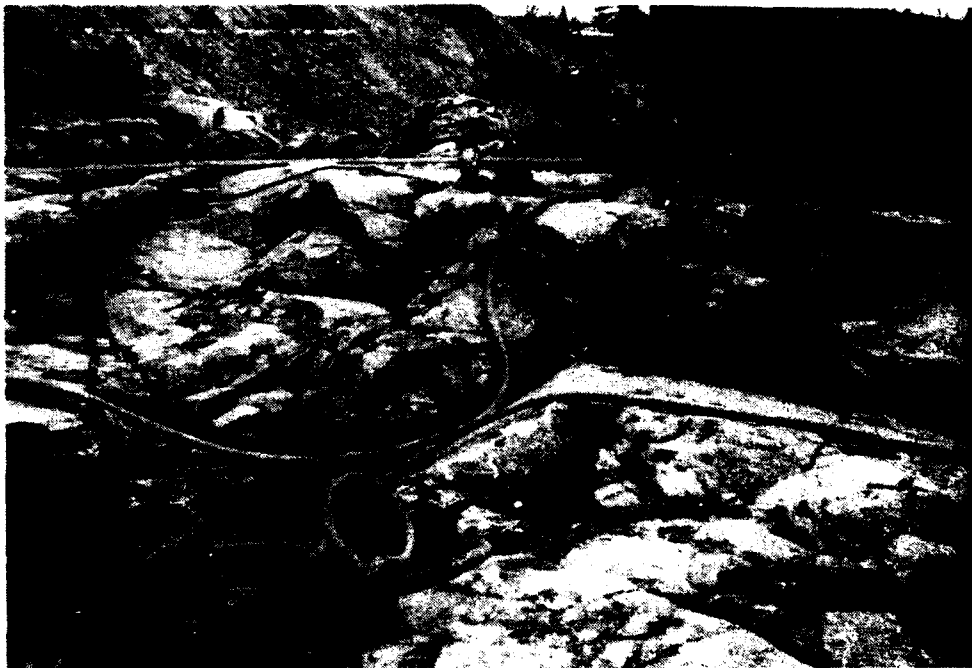
Photo 99 - Monolith 32 foundation - looking east (February 1981)

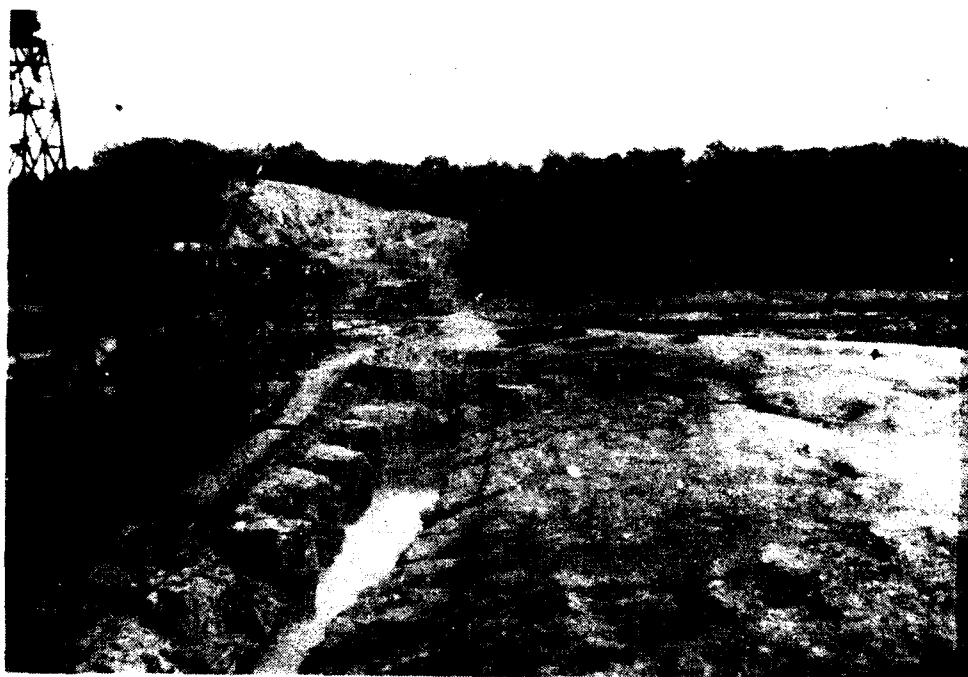
Photo 109 - Power excavation (May 1979)

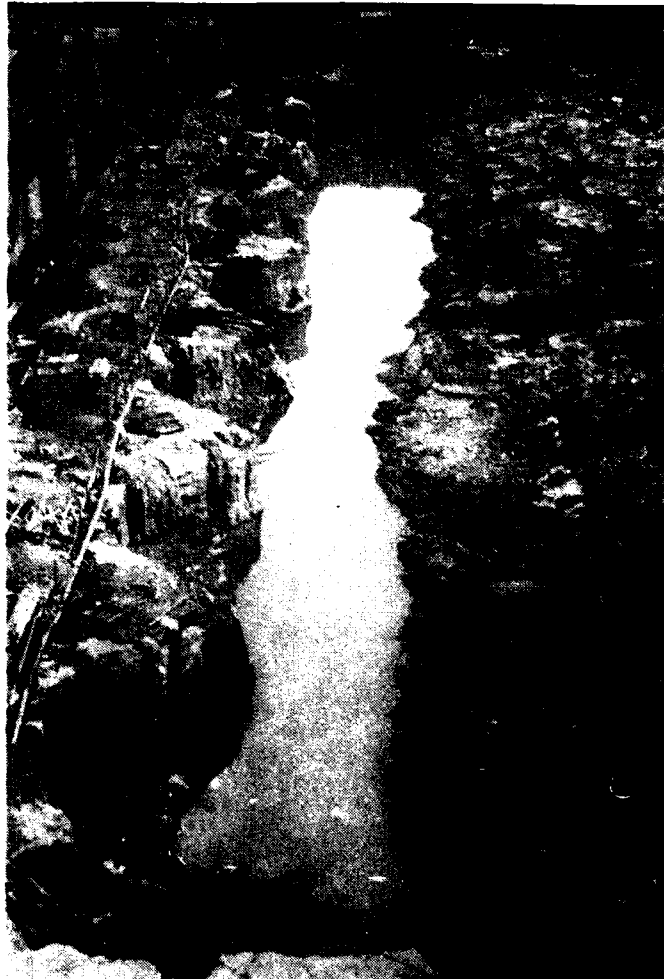
Photo 110 - Powerhouse excavation - note "noses", drainage sump (filled with water) and draft tube tailrace slope 1 on 5. (February 1980)

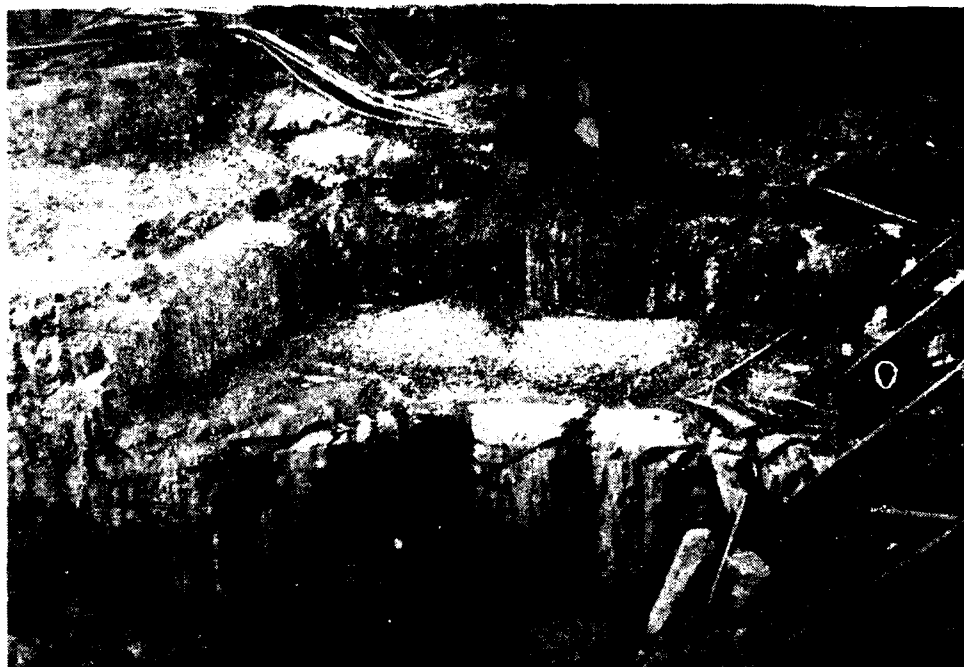
Photo 111 - Powerhouse excavation - erection bay area and
Unit #1. (February 1980)

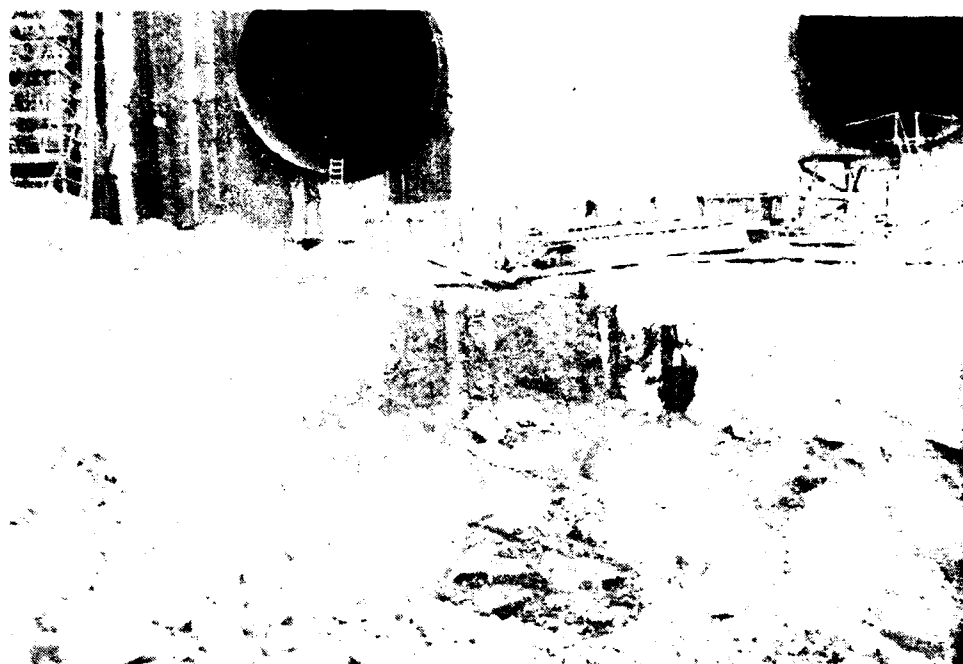
Photo 115 - Powerhouse excavation (May 1981)

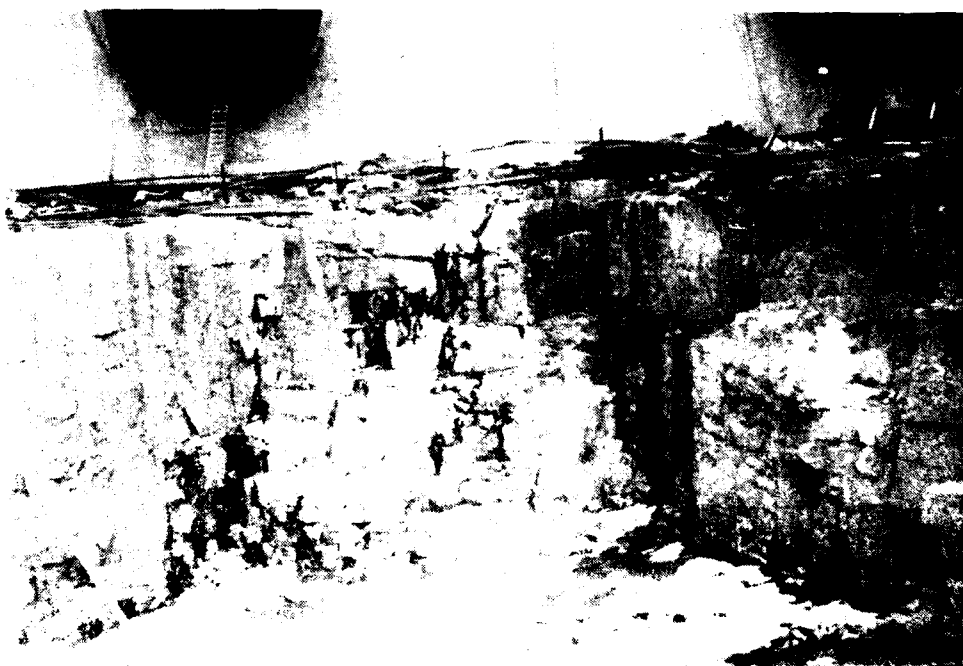
Photo 116 - Powerhouse excavation (May 1981)

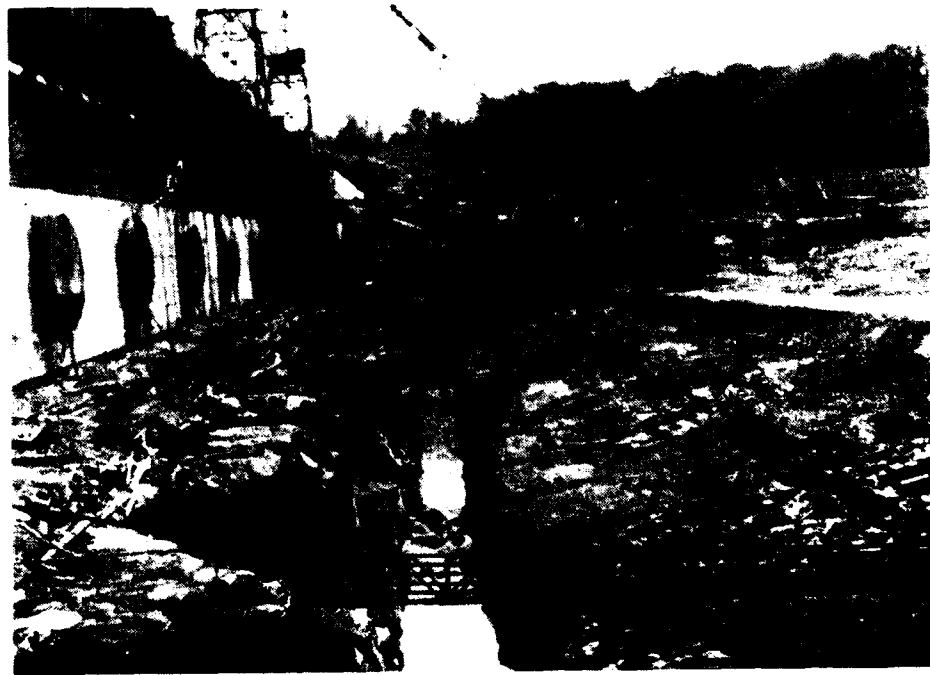
Photo 120 - Powerhouse excavation - viewing east (April 1981)

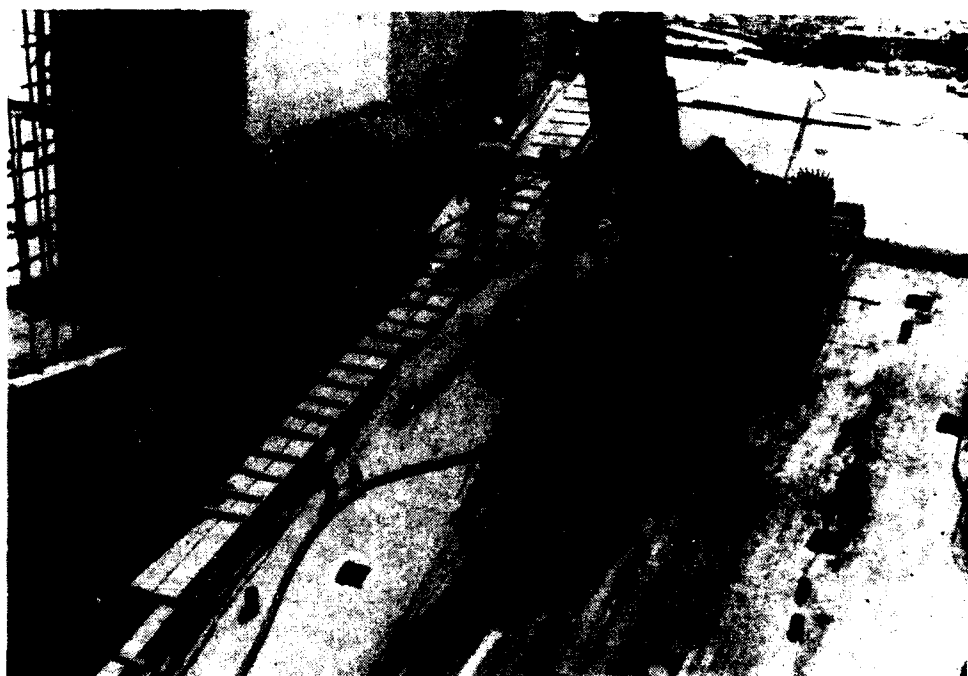
Photo 129 - Drilling foundation relief drains - draft tube area.(1982)

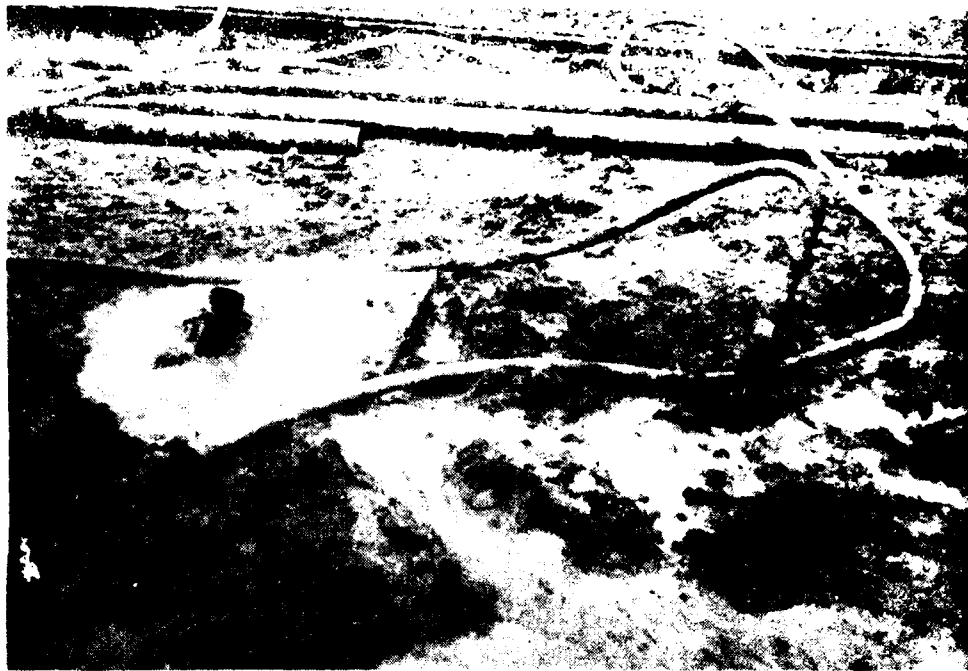
Photo 134 - Pressure washing with communication. These pipes extend 20-40 feet down through overburden and the communication is probably at the overburden/rock contact. (February 1980)

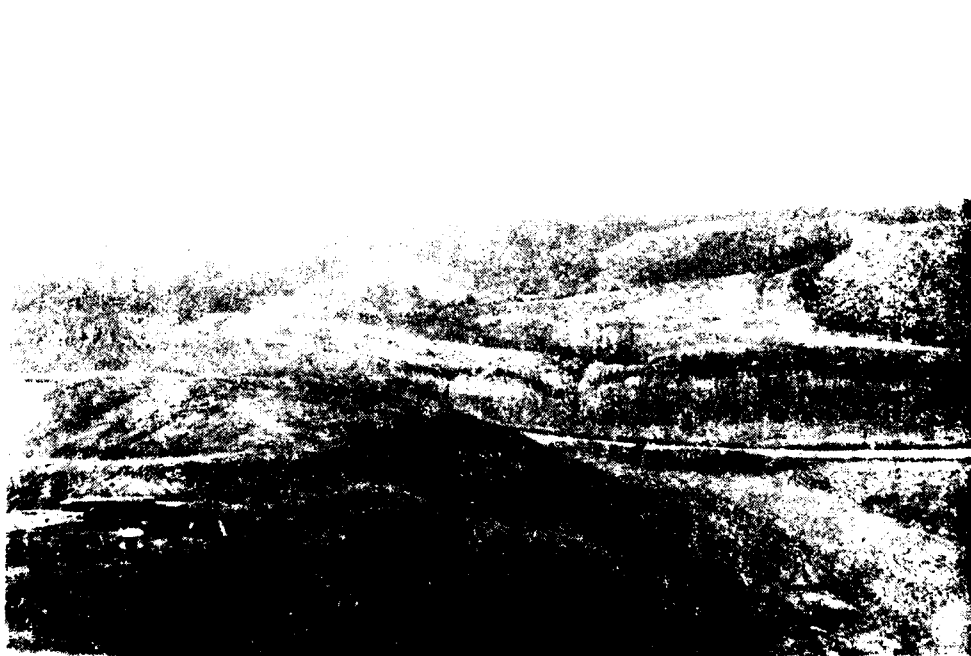
Photo 135 - Cross-section of trench during Class I excavation. (December 1979)

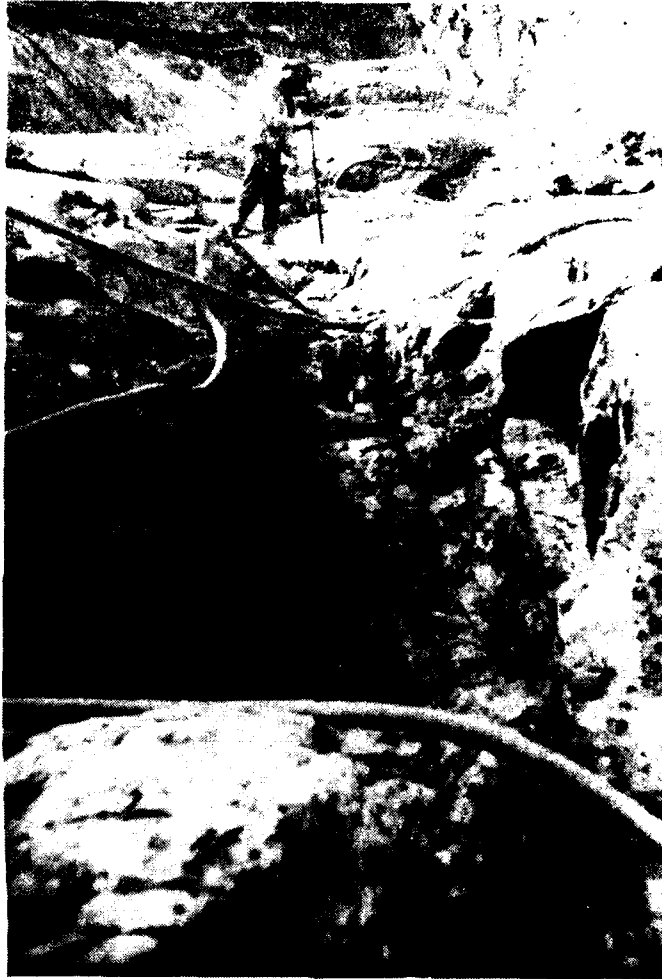
Photo 136 - Foundation conditions, Georgia west - approximately Stations 9+00 to 10+00. Some additional excavation was done in this area.

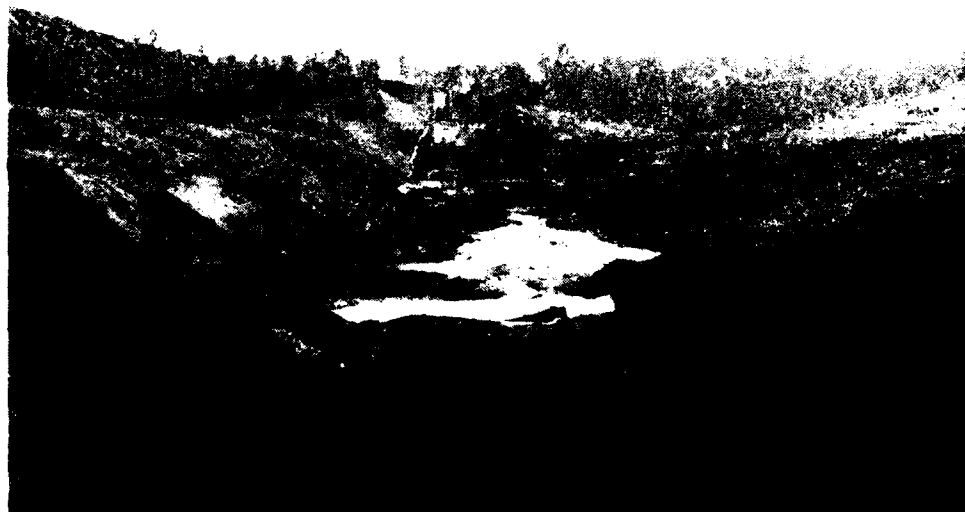
Photo 140 - Georgia west excavation - approaching diversion channel foreground (April 1980)

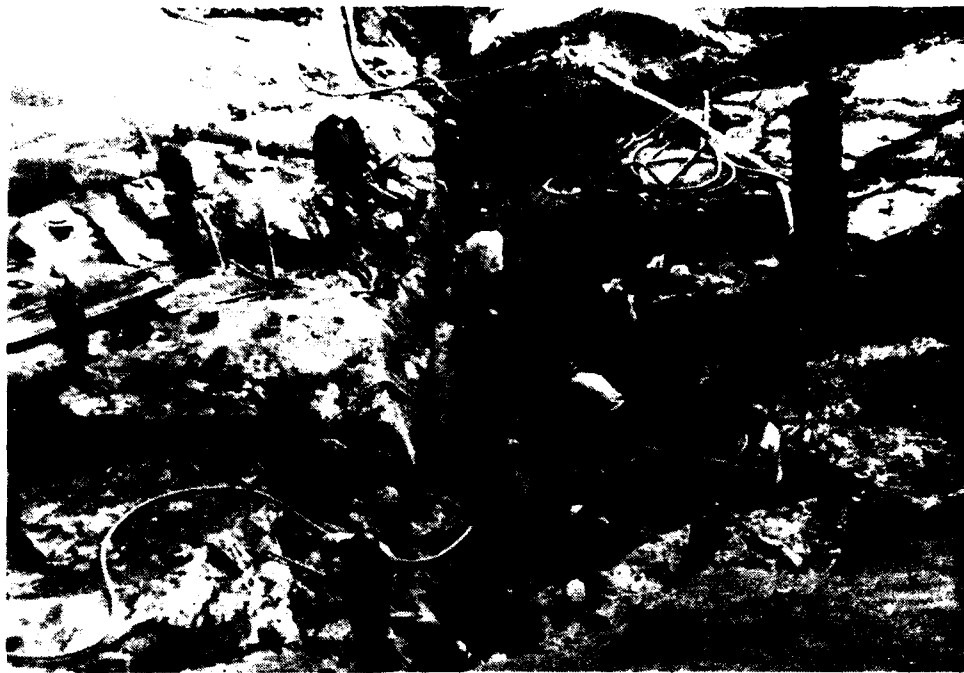
Photo 141 - Cross-dike treatment at Station 7+85.

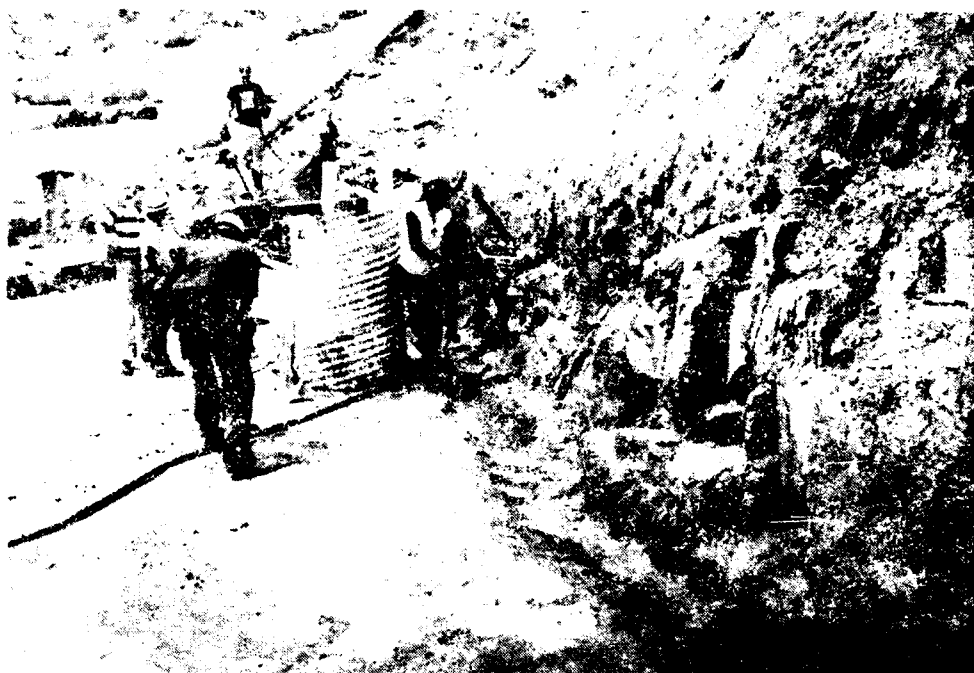
Photo 151 - "Bathrub" treatment - compaction coarse filter
around area after concrete placement.

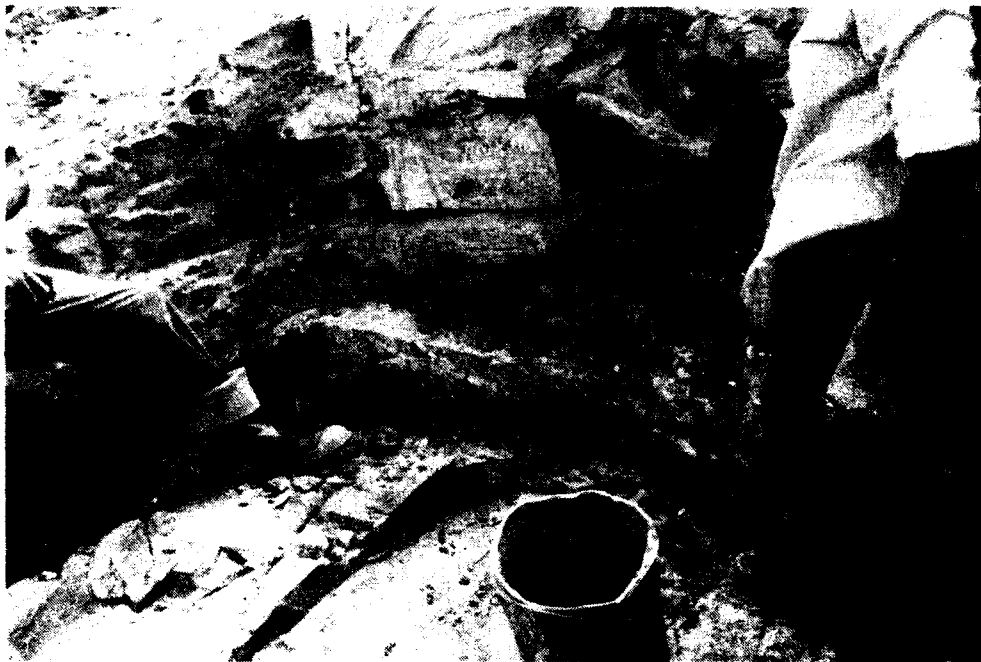
Photo 157 - "Bathtub" treatment - placing concrete by hand.

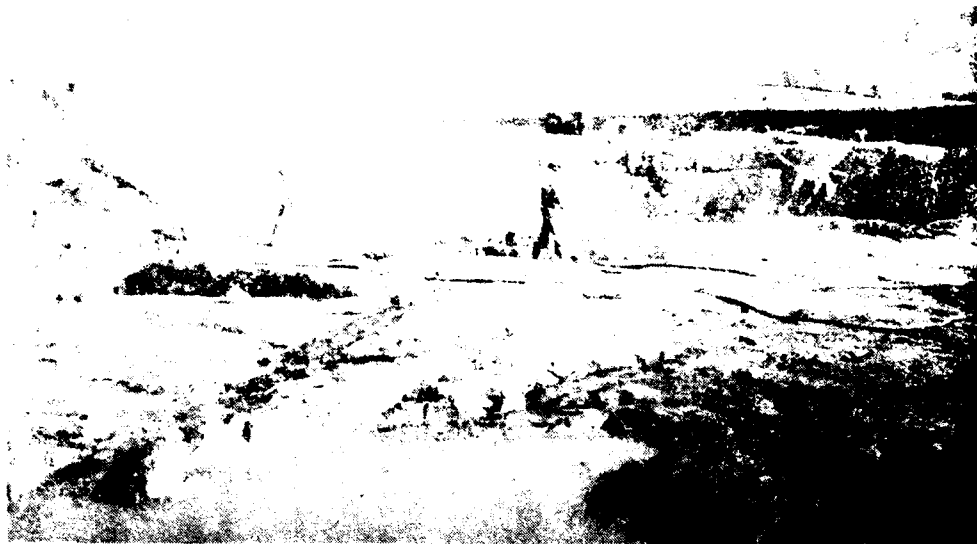
Photo 160 - Georgia east embankment cleanup. Note quarry operation in background.

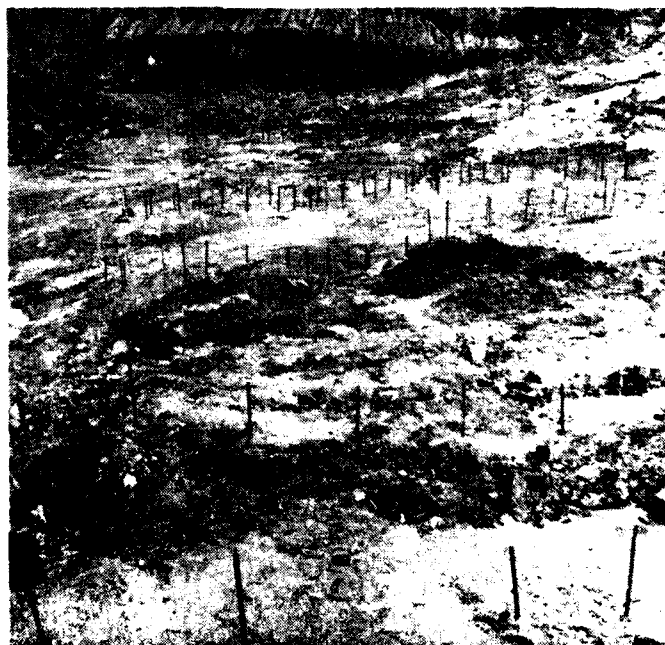
Photo 161 - Georgia east embankment cleanup. Note quarry operation in background.

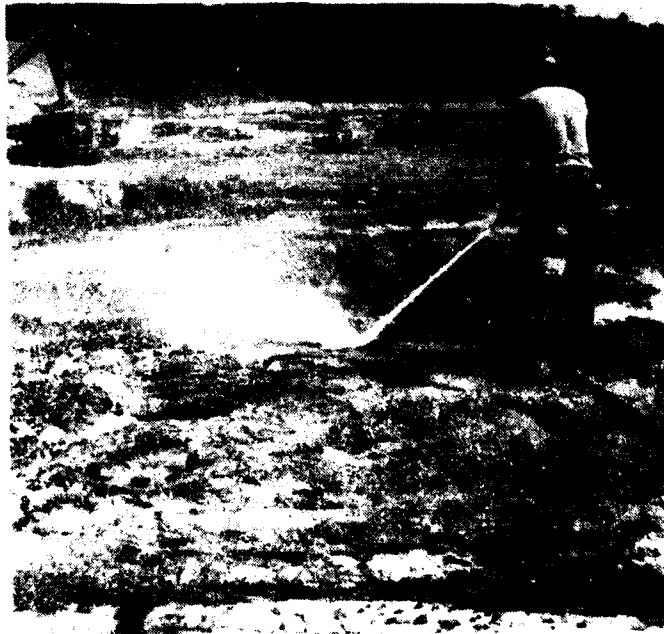
Photo 165 - Washing of Georgia abutment for consultation with
OCE, SAD, and SAS. (September 1978)

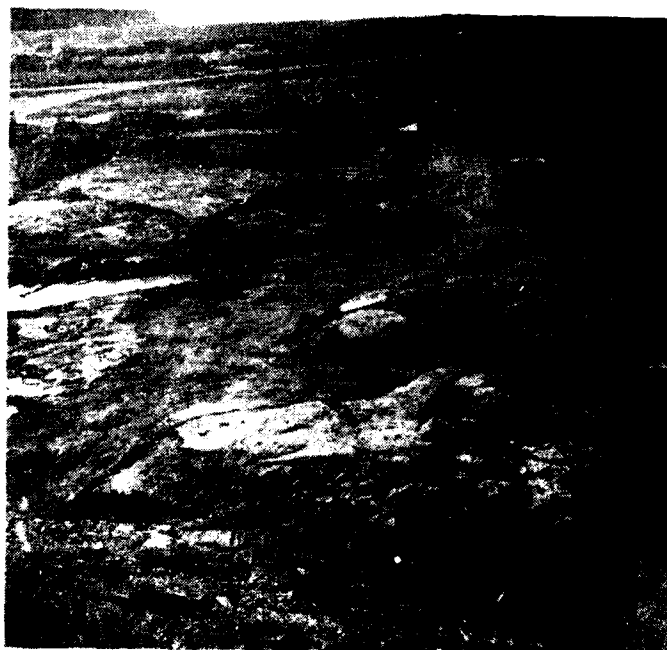
Photo 167 - Georgia abutment Monoliths 3-7 after cleaning by machines. (October 1978)

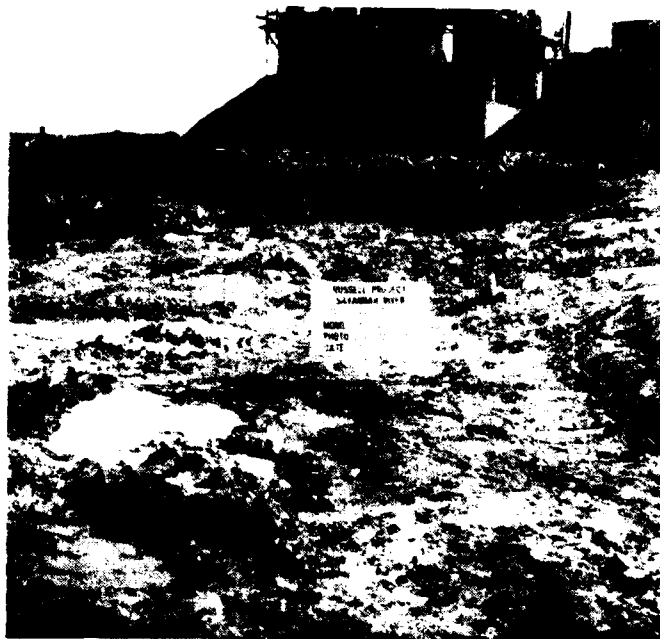
Photo 168 - Georgia embankment downstream Monolith 6

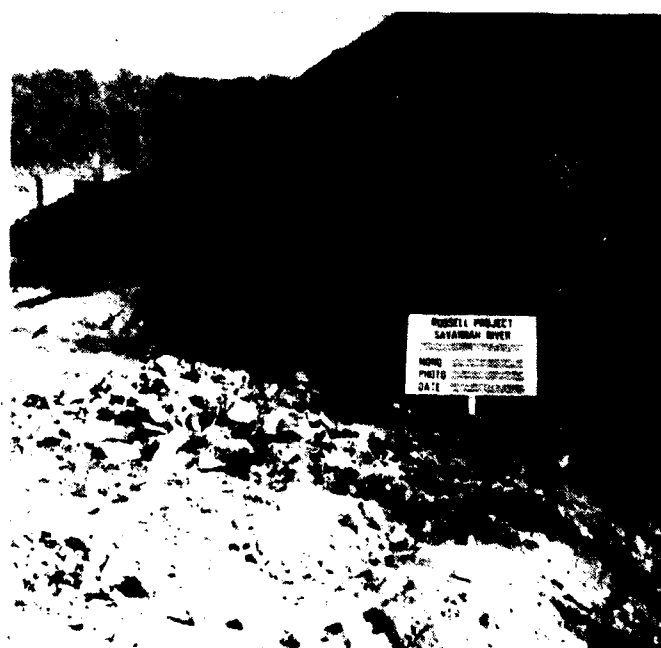
Photo 169 - Georgia east embankment downstream Monolith 2

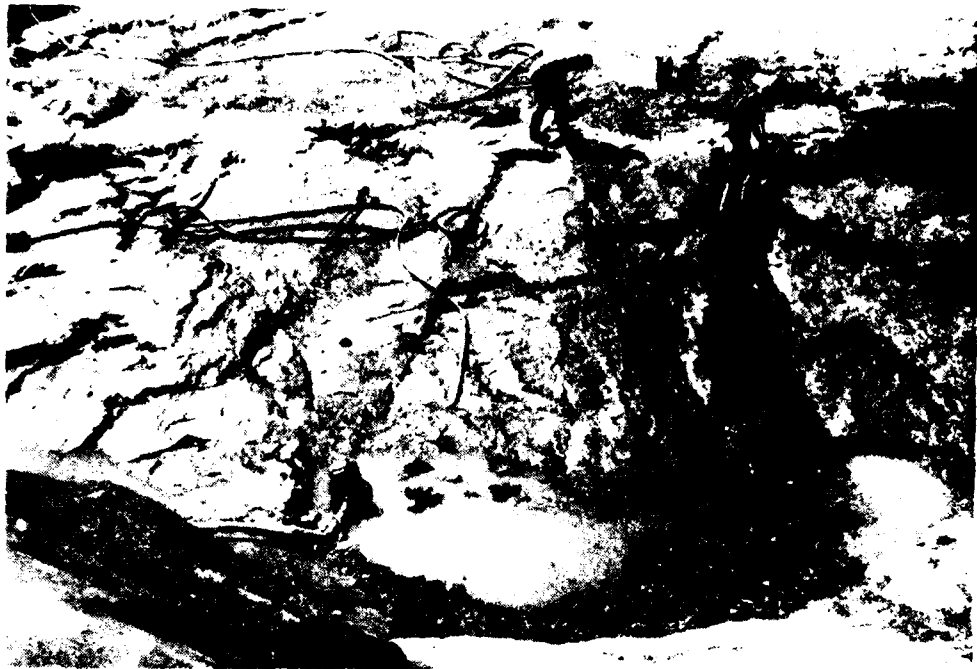
Photo 170 - Georgia east looking west at the
Station 22 + 60 (January 1981)

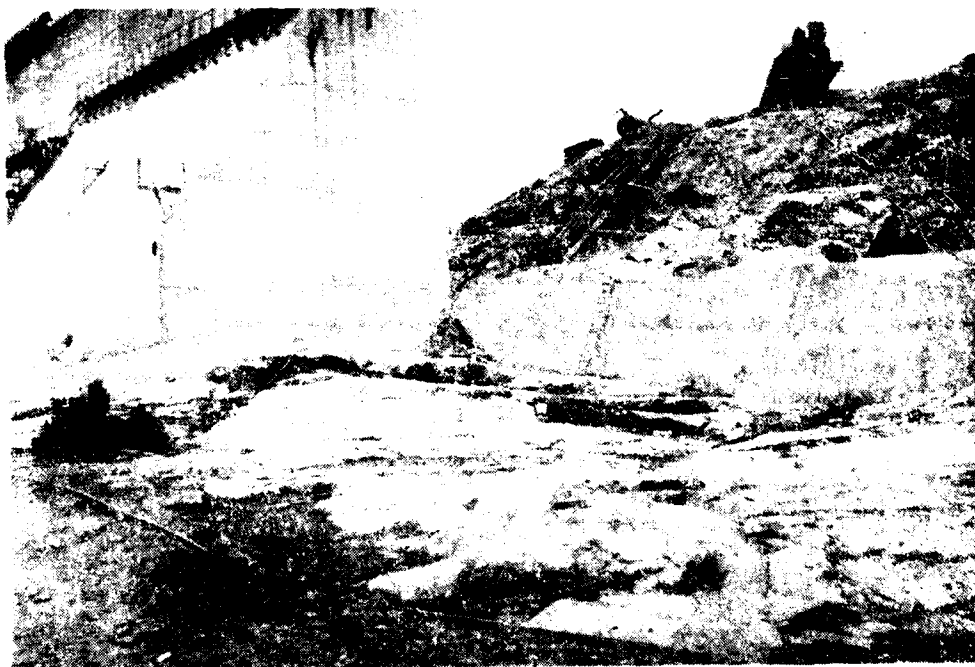
Photo 177 - "Monolith 33" and South Carolina embankment foundation.

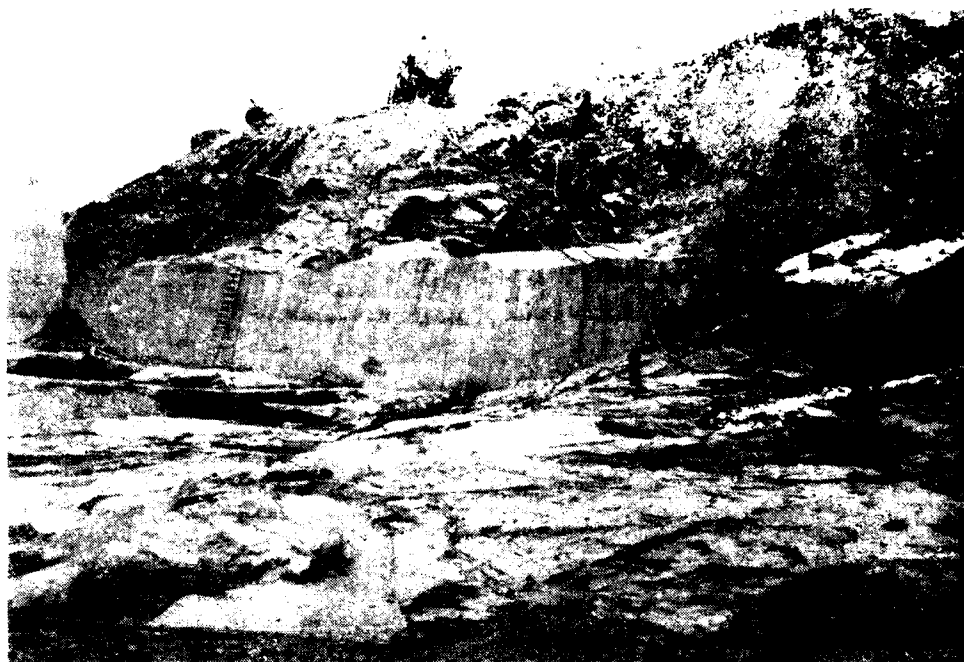
Photo 178 - "Monolith 33" and South Carolina embankment foundation.

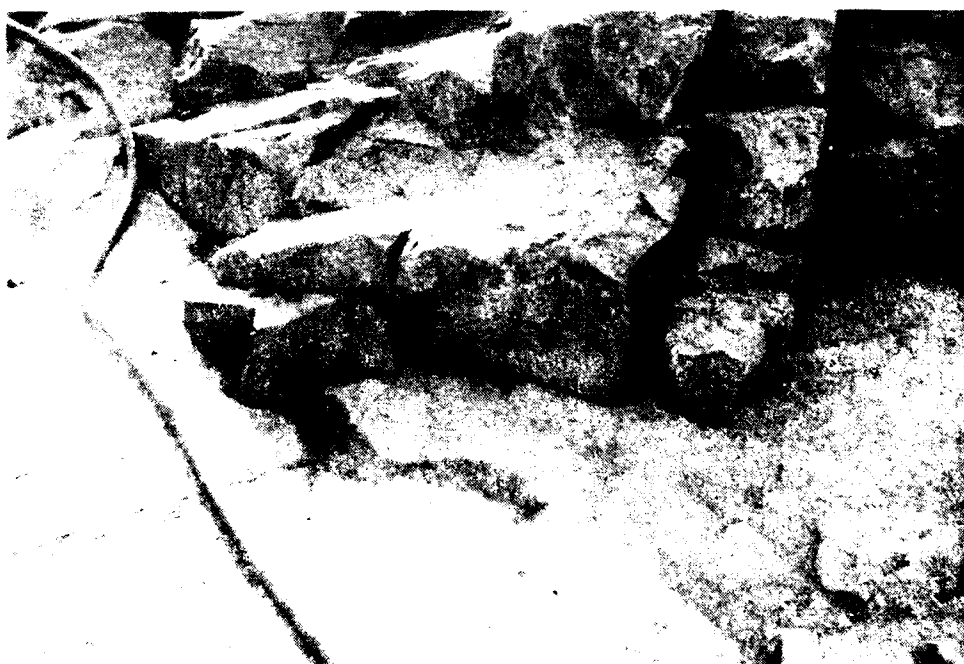
Photo 179 - South Carolina embankment plug downstream of dam.

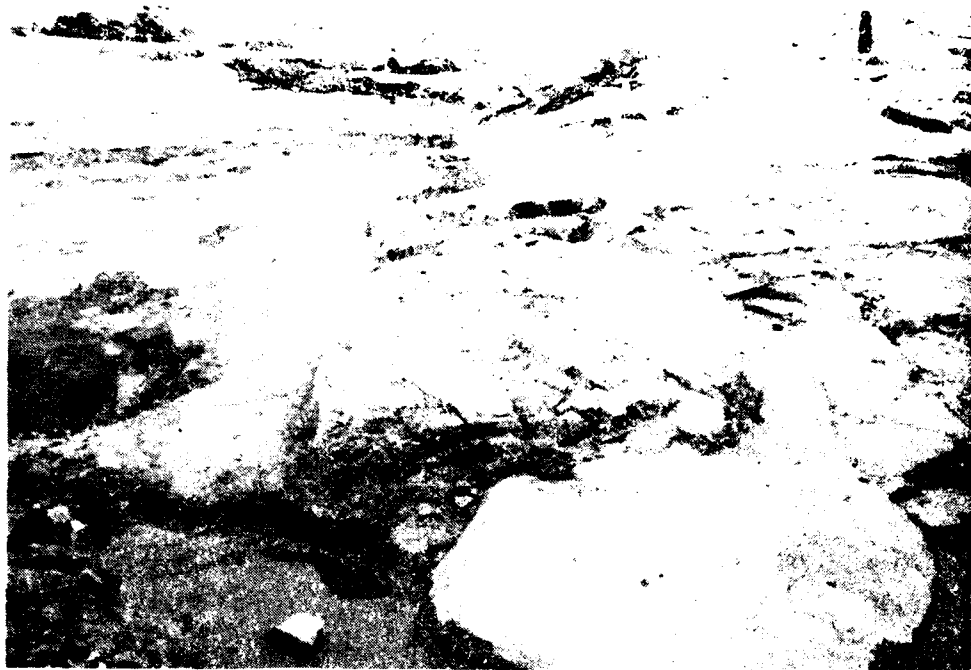
Photo 184 - South Carolina embankment foundation - (11/1/54)

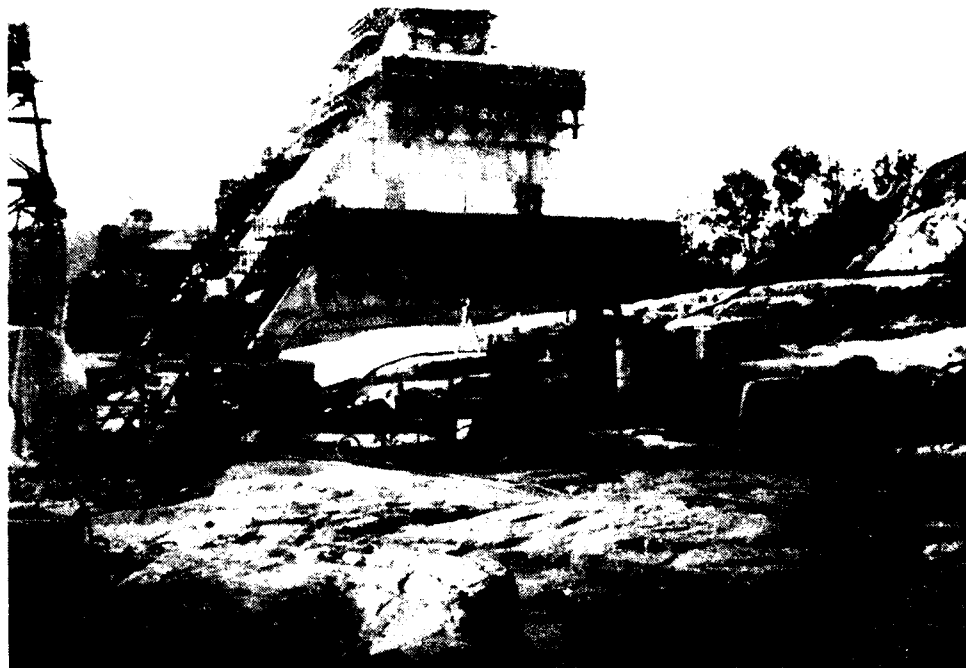
Photo 186 - Grout plant - South Carolina embankment.
